Paunnacussing Creek Assessment and Conceptual Design Ideas for Solebury Township, PA

Prepared for
Wild and Scenic Rivers Program, National Park Service
and
Solebury Township, PA

Prepared by
Dr. John Field
Field Geology Services
Portland, ME

November 2023

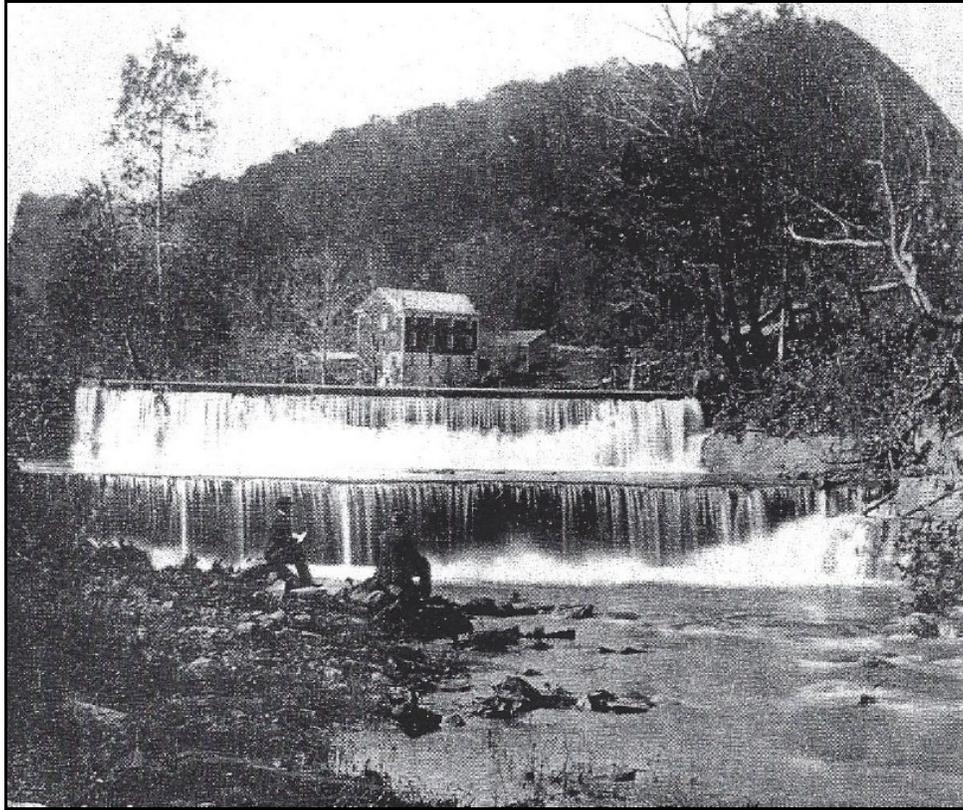
Five mill dams and associated ponds were present between Carversville and Lumberville in the 18th and 19th centuries (Figure 1; Granzow, no date). At least one of these dams, at Michener's Mill, was quite high, likely more than 15 feet high based on historical photographs (Figure 2). Flooding from a hurricane in 1885 is believed by some people to have filled the mill ponds with sediment, after which most of the mills did not recover (Granzow, no date). However, others have voiced skepticism as to the flood's impact on the mill dams (Bill Tinsman, email communication, 2023). Regardless of the timing, the

Figure 2. Double cascading dam at Wall Mill on Paunacussing Creek in a photograph believed to have been taken around 1880 (about 1,500 ft upstream of River Road- see also Figure 1). From Graznow (no date).

Some continuing erosion on Paunnaucussing Creek may be linked to the demise of the former mill dams. While bedrock was observed on the bed of Paunnaucussing Creek during the site visit, no waterfalls were observed, so sediment behind the dams could have accumulated to the full height of even the tallest dam (Figure 2). The stream banks viewed near the intersection of Fretz Mill and Fleecydale Roads expose sediment that may have been deposited behind a mill dam, perhaps during the 1885 flood (Figure 3). The ongoing erosion of the banks may reflect the downcutting and widening of the channel through the old mill pond sediments. A natural gas pipeline crosses the creek (Figure 4a) immediately upstream of a former dam (Figure 4b) near the end of Short Road. The pipeline is protected by articulated concrete matting that has become partially undermined (Figure 4a). The damage to the matting could be due to downcutting and widening of the sediments deposited behind the former dam.

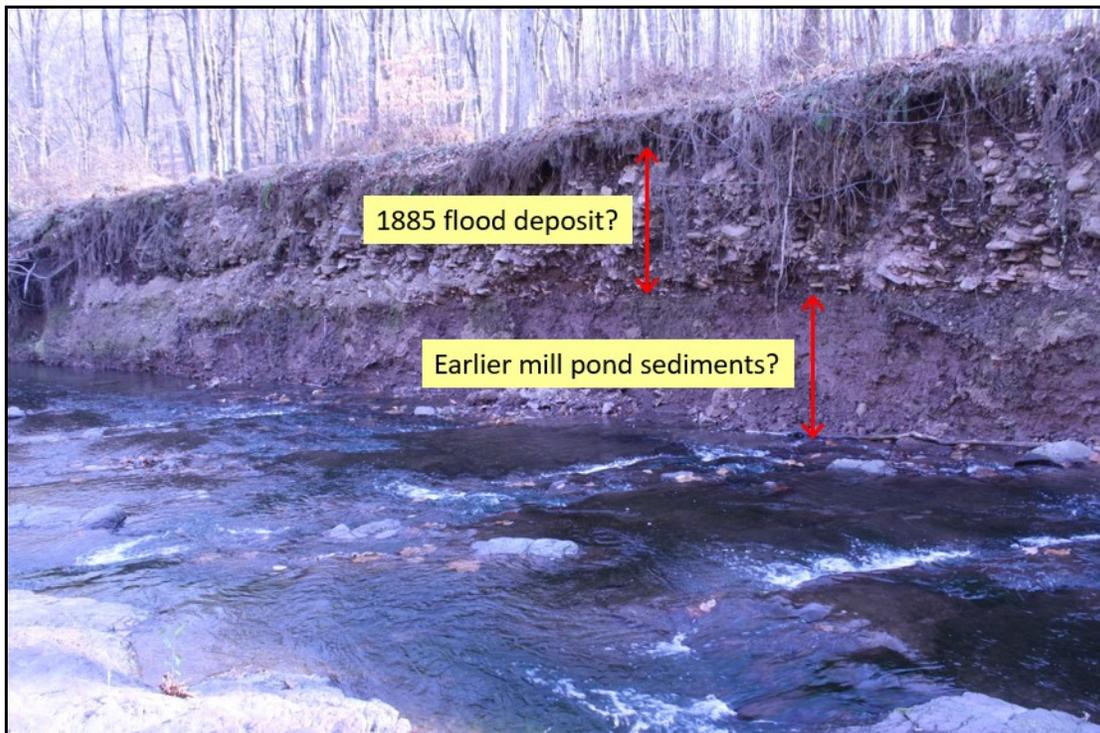
Figure 3. Near vertical eroding bank exposing possible mill pond sediments, including 1885 flood deposits.

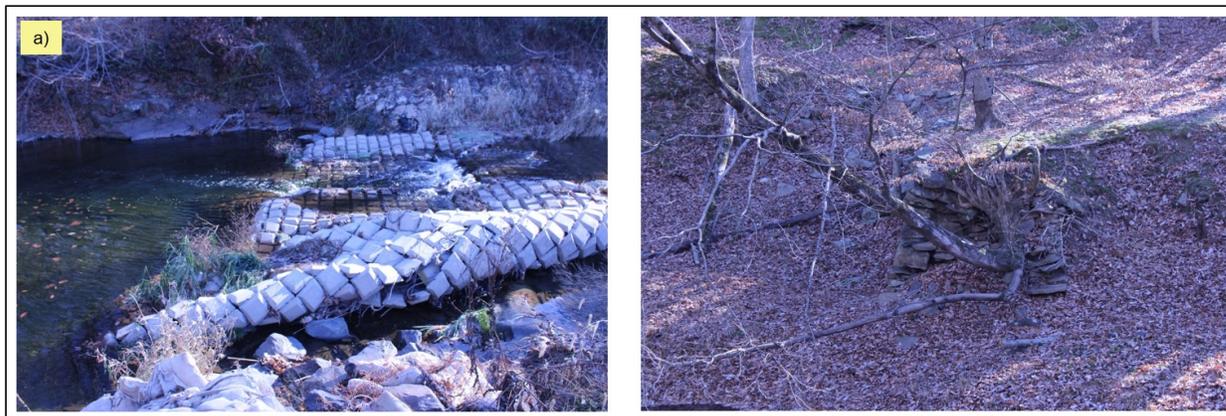
Figure 4. a) Erosion protection matting undermined at natural gas pipeline crossing immediately upstream of b) the remnants of a former mill dam.

Different areas along the stream may be in different stages of channel evolution at the same time, especially when multiple dams fall into disrepair at different times, such as on Paunnacussing Creek. Although speculative, the initial incision on Paunnacussing Creek may be ongoing in some areas (Figure 4a), widening in others where the channel has downcut to bedrock (Figure 3), and elsewhere floodplains are present that have been reestablished within the former impoundments or perhaps were never disturbed by the dams. Anticipating where and how severe erosion may be in the future will require: 1) confirming the presence of impoundment sediments in the stream banks; 2) identifying areas of continuing channel incision by analyzing a longitudinal profile of the channel; and 3) better understanding where erosion is currently occurring relative to the former dam locations. At a minimum, bank erosion and widening of the channel will likely persist in places as the channel's response to the absence of the dams continues.

Infrastructure constraining a stream can sometimes be relocated to restore natural channel processes. The gas pipeline is perhaps the most threatened critical infrastructure crossing Paunacussing Creek as the current scour protection has been damaged by undermining (Figure 4a). The hardening of the bed and banks of the channel through the use of articulated concrete matting is inconsistent with Paunacussing Creek's WSR status, so an alternative approach to protecting both the pipeline and the creek's outstandingly remarkable values is needed. Directional horizontal drilling offers a method for relocating the pipeline at a greater depth safely below the maximum expected scour depth of the creek bed (Web citation 4 – see pages 3-20 to 3-21). Geotechnical studies will need to be completed to determine if the soils and rock underneath the stream bed are suitable for this type of drilling. If horizontal drilling is deemed possible, the current concrete matting on the bed and banks could be removed and natural channel adjustments allowed to proceed without threatening the pipeline.

- Relocating infrastructure	4	Relocate infrastructure so no longer in conflict with natural river processes	Provide additional space for flood flows and channel adjustments	Gas pipeline crossing (40.38967, -75.05995)	Relocate pipeline vertically so below expected scour depth
Watershed management

- Remove hard armor	5	Removal of rock, concrete, or steel used on banks but not protecting infrastructure	Allow for natural processes and reduce erosive forces elsewhere	Gas pipeline crossing (40.38967, -75.05995)	Assumes pipeline relocated below scour depth

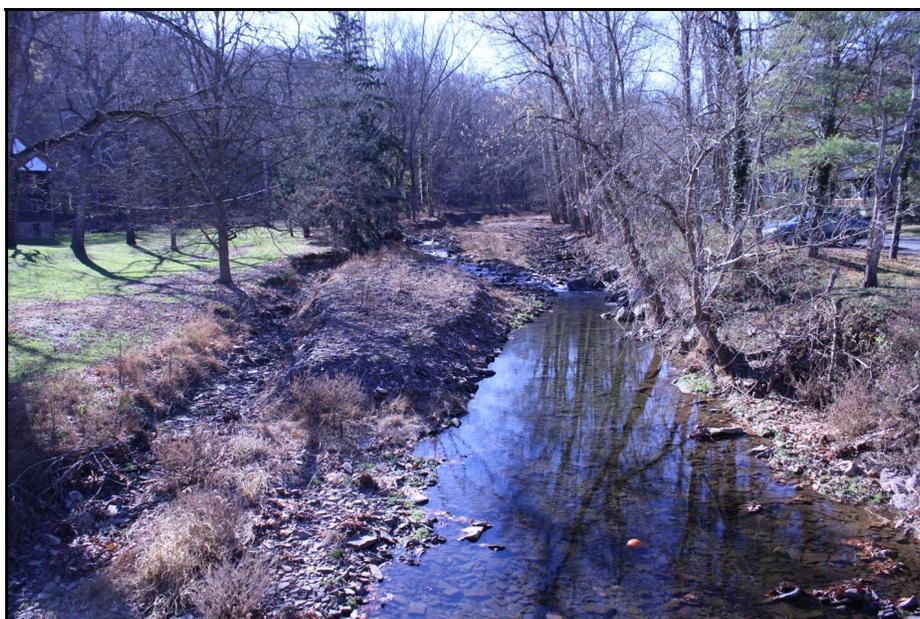
Sediment from the 1885 and other floods, coupled with erosion from behind the former mill dams, has resulted in excessive deposition further downstream. The delta present in the Delaware River at the mouth of Paunnaussing Creek is not shown on the 1876 Bucks County Atlas when the mills were still active (Figure 1) but does appear on the 1891 historical topographic map (Web citation 2) surveyed shortly after the 1885 flood. If accurate, these maps are consistent with the 1885 flood and demise of the dams resulting in the delta's formation – a feature not seen at the mouth of other nearby tributaries. Excess deposition continues today near Lumberville where backwatering of the Delaware River during flood stage reduces flow velocities enough on Paunnaussing Creek to cause the formation of large gravel bars (Figure 5). This deposition in turn concentrates flow against the banks, causing further erosion and flooding as the channel infills with sediment.

Figure 5. Large gravel bars infilling the channel upstream of River Road near the Delaware River confluence.

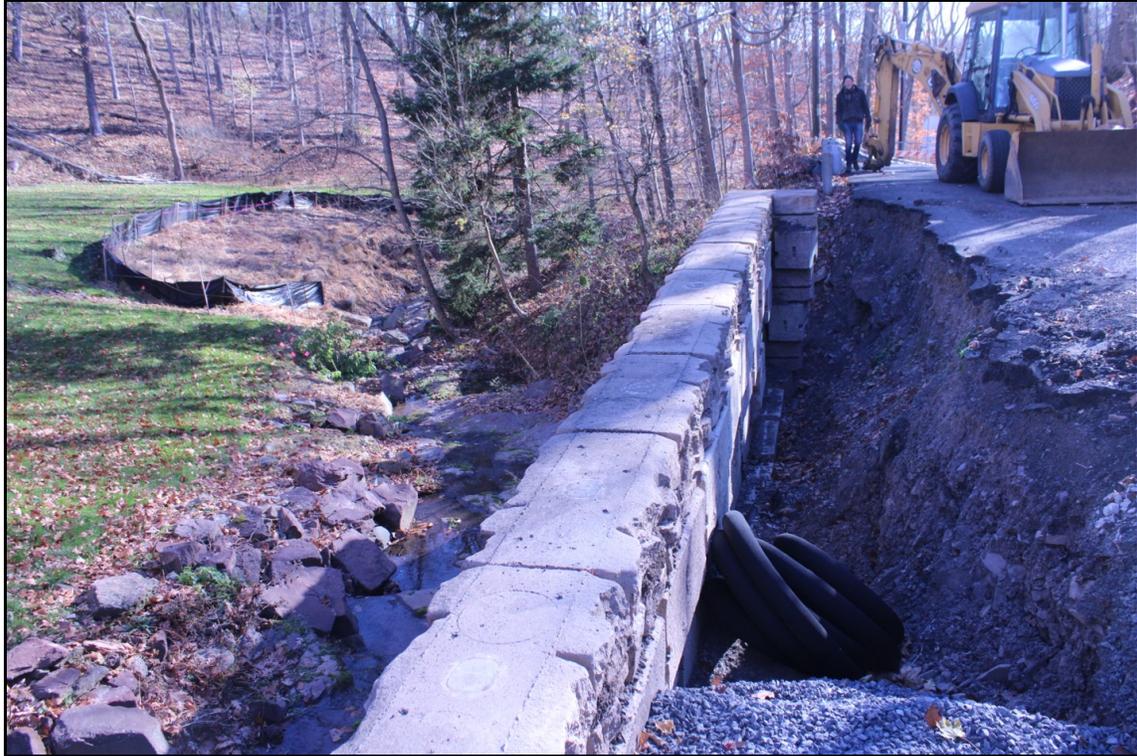
Severe scour at an undersized culvert damaged a portion of Short Road on a small steep tributary (undergoing repair at the time of the site visit) (Figure 7). This site highlights the potential for the tributaries and the dozens of small culverts on them to impact Paunacussing Creek itself. Scour at the outlet of a culvert is only one potential source of excess sediment that can be transported downstream to Paunacussing Creek. In addition, the initial scour at a culvert outlet has the potential to initiate much larger mass failures by undermining the steep high banks common to many of the watershed's tributaries, particularly those between Carversville and Lumberville. Finally, years of sediment stored upstream can be released suddenly if a culvert is swept away during a large flood. These sources of excess sediment (i.e., above what might occur naturally) can increase the sediment load to the less steep and unconfined Paunacussing Creek where deposition becomes more likely. Rapidly growing sand/gravel bars, in turn,

increase the risk for flooding and bank erosion on Paunnacussing Creek. While these issues would arise only during a large storm event, the presence of numerous undersized culverts on tributaries throughout the watershed increase the risk of large sudden sediment pulses entering Paunnacussing Creek.

Figure 7. Short Road under repair from scour damage at undersized culvert.

Numerous roads cross Paunnacussing Creek and its tributaries throughout the watershed. Many of these crossings are undersized (i.e., narrower than the channel width), resulting in backwatering and deposition upstream (Figure 6a) during storm events and scour downstream (Figure 7). By resizing the crossings to at least match the width of the channel and also providing for supplementary relief culverts where floodplains are present, the deposition and erosion around the structures can be minimized as the continuity of sediment transport is restored. Appropriately sized crossings also enable more efficient transport of woody material and aquatic organism passage, so resizing the structures would have an environmental benefit as well. Resizing numerous crossings

throughout the watershed will take considerable time and money to complete, so basin-wide benefits from these actions will likely take decades to emerge. However, immediate benefits will accrue in the vicinity of each structure replaced. A comprehensive crossing assessment should be completed throughout the watershed to identify the highest priority crossings to replace based on: 1) the relative size of the structure compared to the channel and anticipated effects of climate change; 2) whether the road approaches block the floodplain; 3) the severity of deposition and erosion at the crossing; and 4) the remaining life expectancy of the structure. Hydraulic modeling should be completed with the crossing assessment to ensure that the replacement of one crossing will not lead to more severe problems at a remaining undersized crossing downstream.

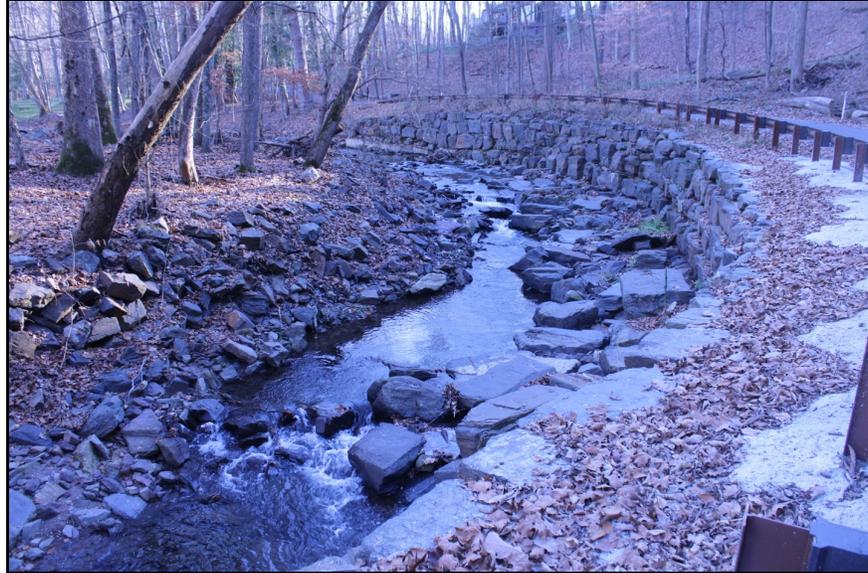
Not only do road crossings potentially exacerbate flooding, erosion, and deposition on Paunnacussing Creek but roads built along the banks of the creek can as well. Fleecydale Road runs right along the edge of Paunnacussing Creek for much its length between Carversville and Lumberville. This creates a need to protect the road from bank erosion and the edge of the road is indeed armored in many places with large rock (i.e., riprap) and/or a wall (Figure 8). The road occupies a portion of the former channel and floodplain and has likely initiated the erosion and subsequent armoring of the opposite bank (Figure 8). By constraining the channel, flow velocity and erosive force increase, which can potentially undermine the road itself or cause erosion and deposition elsewhere.

Figure 8. Fleecydale Road and its protection along the edge of Paunacussing Creek occupy a portion of the channel and may be the cause of erosion and subsequent armoring of the opposite bank.

- Removing unused roads	3	Removal of damaged roads unlikely to be rebuilt due to high costs or other reasons	Provide additional space for flood flows and channel adjustments	Fleecydale Rd	Closed portion from Old Carversville Rd to Fretz Mill Rd
